# Manhole Inspection Summary

Manhole # S29AA\_007MH

Insp Date: **12/10/07 1:32 PM**

**Location** Address: **625 HOFFMAN ST**

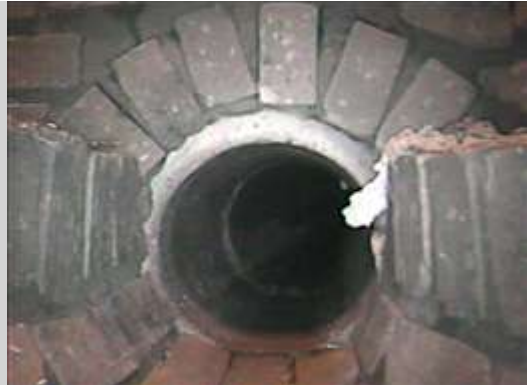
12 O'Clock Outflow

8 in. Circular Gravity Sewer  
Pipe Out @ 12 O'Clock

Pipe Material: **Clay** ☐ Pipe Lined

Invert Depth: **12.16** (ft.) Flow Characteristics: **Fast**

Infiltration: **None** Pipe Seal Cond: **Sound**

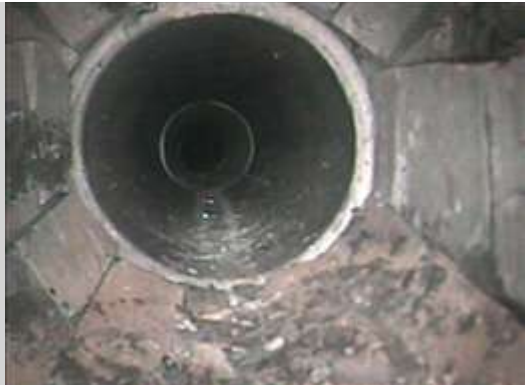
6 O'Clock Inflow

8 in. Circular Gravity Sewer

Pipe In @ 6 O'Clock

Pipe Material: **Clay** ☐ Pipe Lined

Invert Depth: **11.60** (ft.) Flow Characteristics: **None**

Infiltration: **None** Pipe Seal Cond: **Sound**

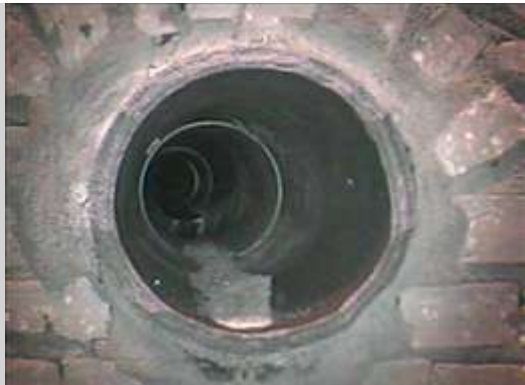
9 O'Clock Inflow

8 in. Circular Gravity Sewer

Pipe In @ 9 O'Clock

Pipe Material: **Clay** ☐ Pipe Lined

Infiltration: **None** Pipe Seal Cond: **Sound**
